To: Donn Stone, Rolluda Architects
From: Tina Cohen, Certified Arborist
Site: **Anjuman E Burhani Community Complex**
15252 NE 51st Street
Redmond WA 98052

Arborist Report

**Anjuman E Burhani Community Complex
15252 NE 51st Street
Redmond WA 98052**

Arborist Services: Tree Inventory

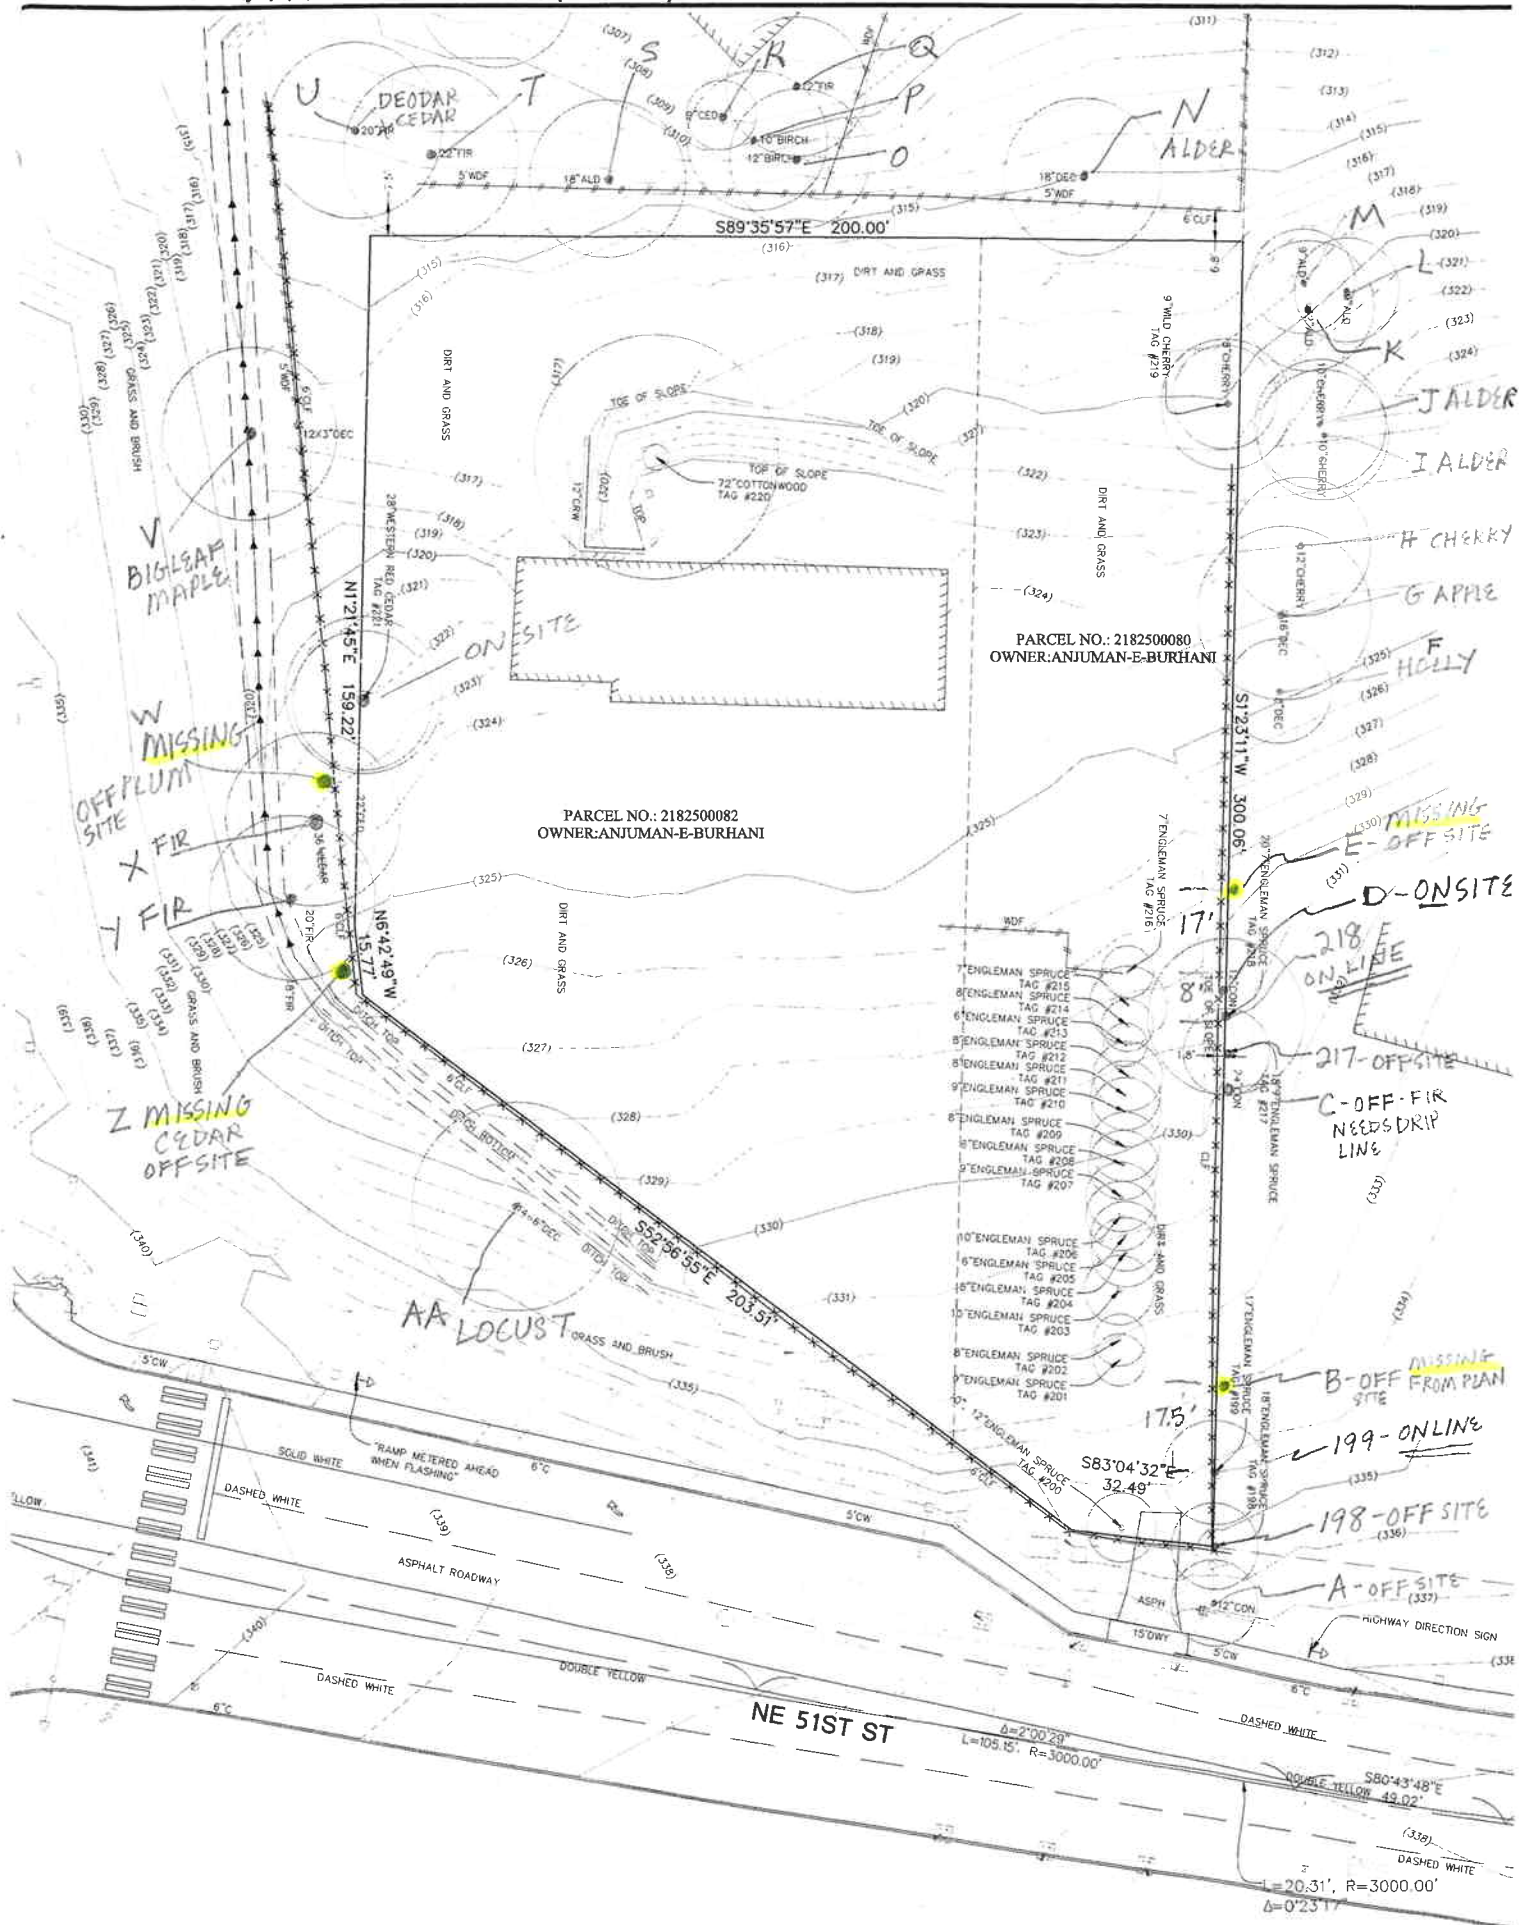
UPDATED SITE PLAN 3/15/13 by TINA COHEN

I gathered information regarding the trees at the Anjuman E Burhani Community Complex on January 28 and March 15, 2013. The enclosed spreadsheet accompanies the updated site plan. Please ask the surveyors to add the missing trees. The Redmond planner will need to clarify if trees that straddle the property line are considered to be on or off site.

There are 10 Significant trees and zero Landmark trees on the site. The project proposes to remove all on-site trees and mitigation will be determined. The off site trees adjacent to the east and south west property lines will not survive the clearing and grading. Other off site trees will not be affected by the project. The plans need to be updated to show the missing trees and the clearing limits.

All Significant and on site unhealthy trees will be removed for this project. The retention of the off site and straddled trees needs to be addressed during the design and permit process. The contractor will need tree protection specifications.
